## MARINE ACCIDENT BRIEF REPORT

**FIRE ON BOARD THE NETHERLANDS-  
REGISTERED PASSENGER SHIP  
*NIEUW AMSTERDAM*  
GLACIER BAY, ALASKA  
MAY 23, 2000**

**NTSB/MBR-01/01  
PB2001-916402  
Notation 7377  
Adopted July 24, 2001**

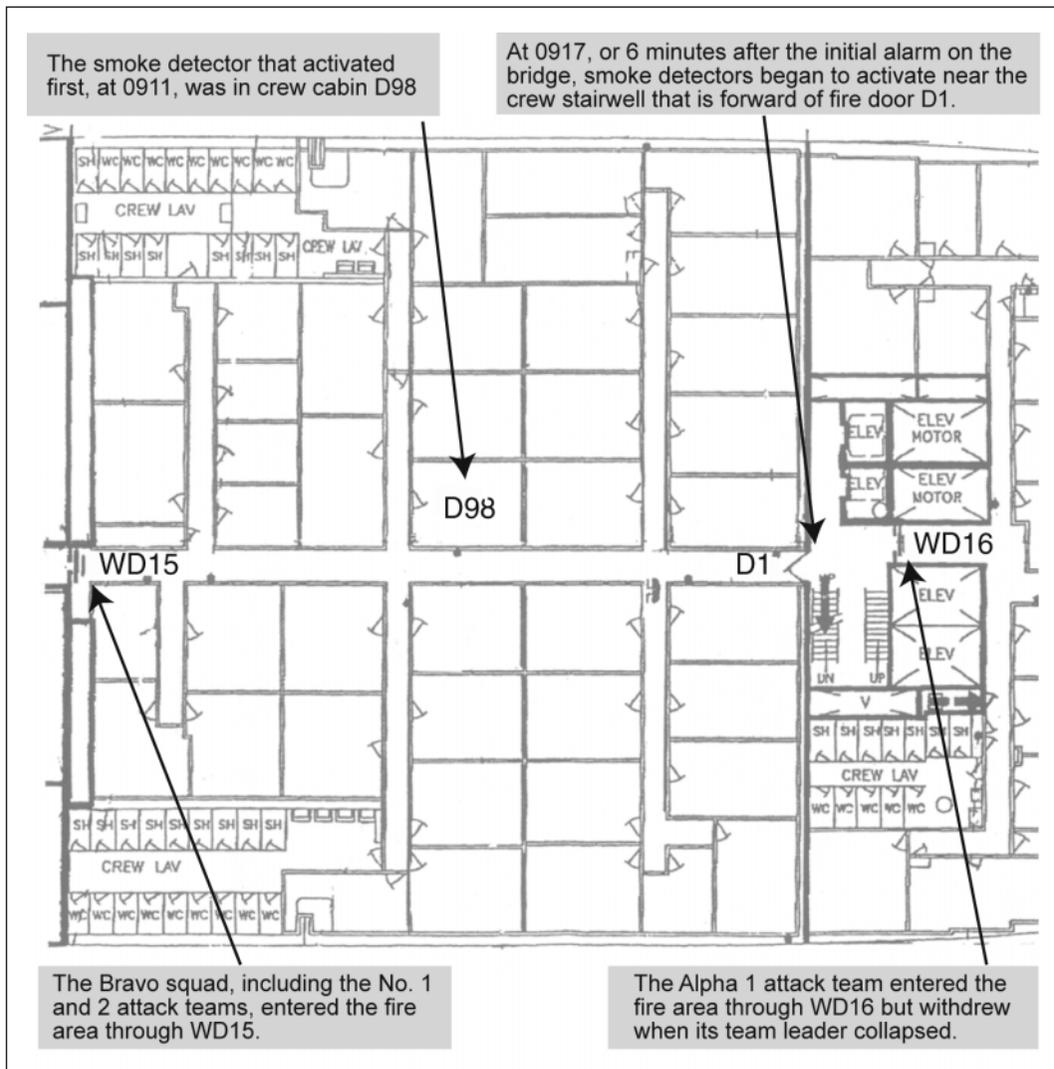
**Figure 3.** Plan view of a portion of D deck. The fire started in cabin D98. Within 6 minutes of the initial smoke alarm activation at 0911, detectors began to activate near the crew stairwell forward of FSD D1.

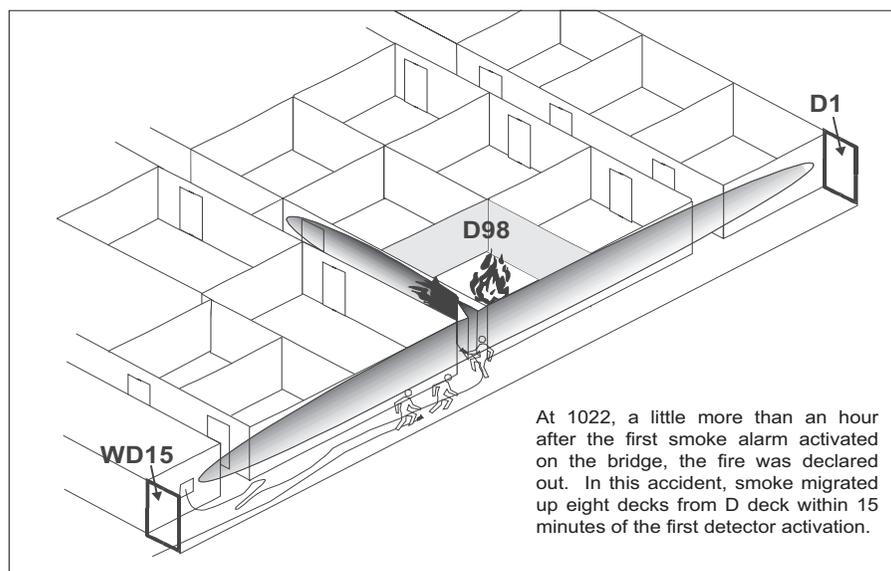
**Figure 7.** The gray area in this illustration shows the fire and smoke damage on D deck.

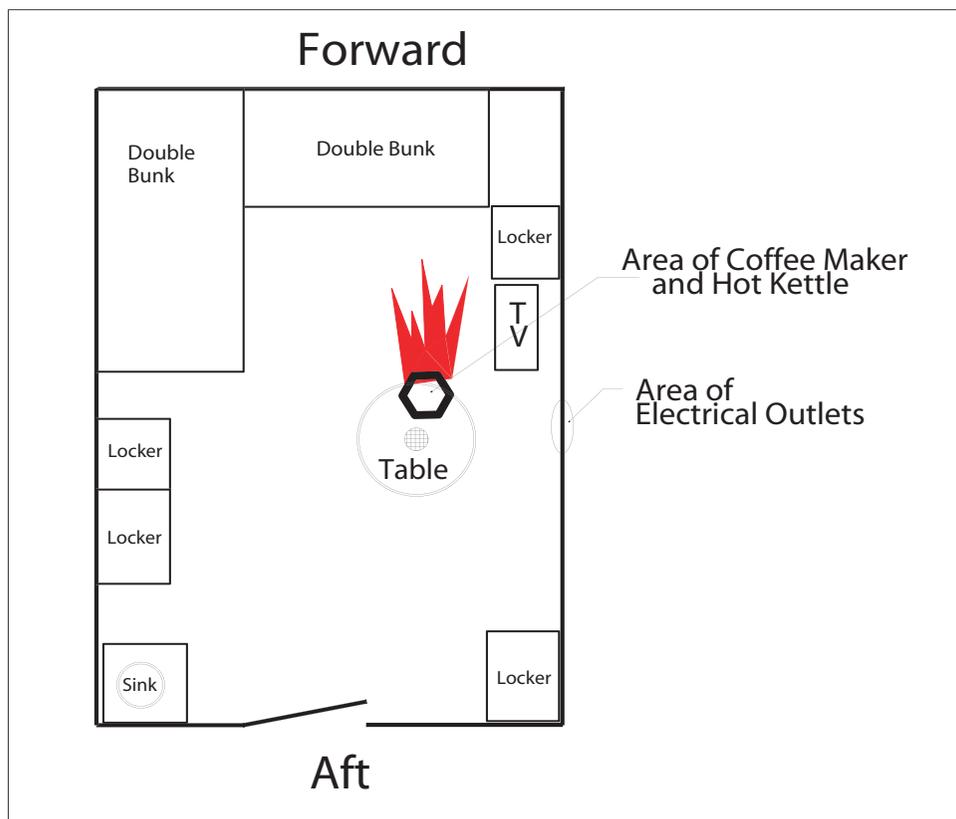
**Figure 8.** Plan view of crew cabin D98.

The ATF conducted a systematic examination of cabin D98 to determine the origin and cause of the fire.<sup>12</sup> Investigators observed burn patterns on the cabin bulkheads and furnishings, indicating that the greatest heat and flame damage came from a point near a small round table in the middle of the room, near the starboard bulkhead. (See figure 8.) In examining the debris in this area, investigators found the remains of a coffeemaker and a hot water kettle (electric). The ATF's examination of the coffeemaker showed damage indicative of heating and melting from the exterior to the interior of the appliance. The coffeemaker's internal heating element and associated electrical components were undamaged. The remnants of the hot water kettle heating element showed metal distortion indicative of internal heat damage that extended from the inside to the outside of the appliance. Investigators eliminated other possible sources of ignition, including any other electrical source and smoking materials, in this cabin area and concluded that the hot water kettle was the source of the fire.

According to the ship's safety officer, Holland America has had a long-standing policy prohibiting cooking and water heating appliances in crew berthing areas. As a result of the *Nieuw Amsterdam* fire and a fire on another Holland America ship, the company issued a fleet advisory stating that any crewmember found to be cooking or in possession of a cooking appliance in a crew cabin would be immediately terminated. The advisory also stipulated that the masters of all vessels were required to have weekly inspections, as well as unannounced, periodic random searches, of crew cabins to check for cooking appliances.
